# Flickering issue with 185 HV

Investigation Report  
R&D Illuxtron International  
August 2016

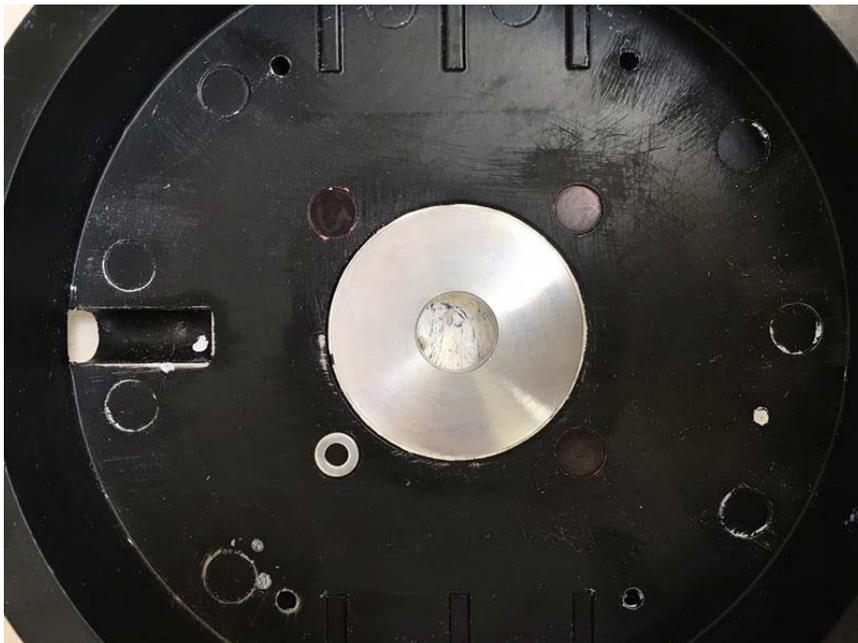
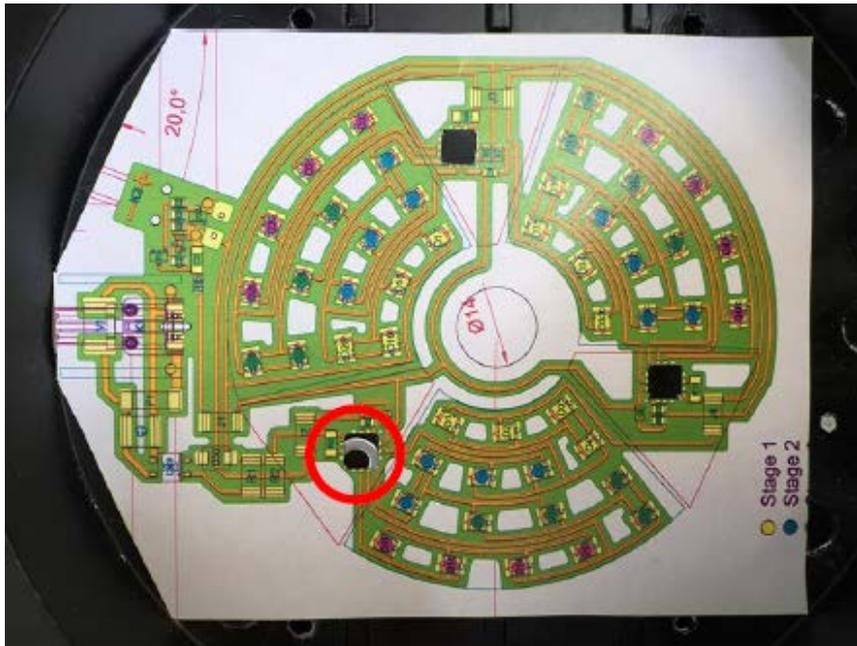
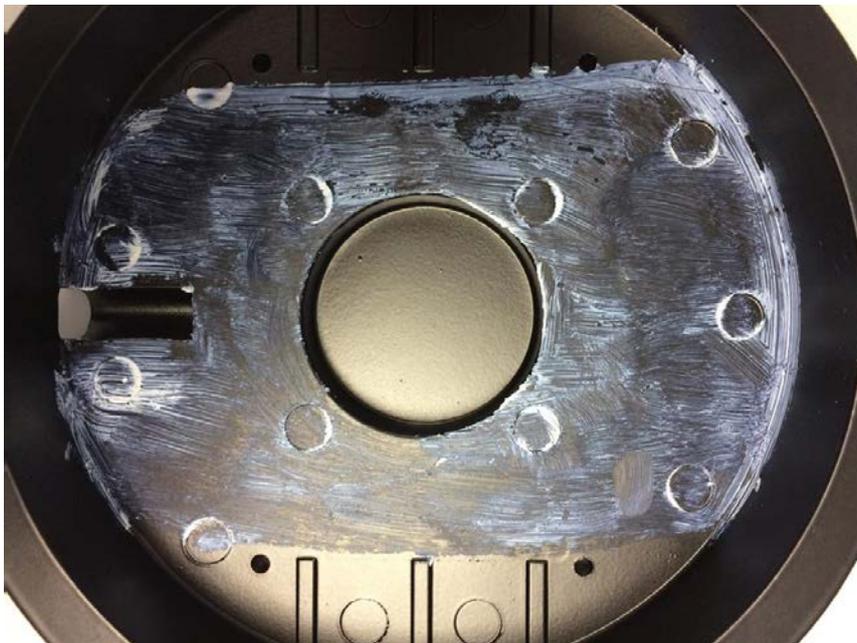
1. Temperature has been found to be a problem with the IC in the majority of cases.
2. It appears that one of the three IC's is located exactly above injection point of a heat sink, which has not always been sufficiently filled with heat past, resulting in less than optimal contact with the heat sink.

As a result, heat is increased enormously at that spot and comes up to the maximum temperature of 150 ° C that is allowed in the IC, causing it to go into overheat protection, resulting in light flashes.

1. The design of the PCB has been adjusted, so that the IC sits in a different spot, away from the injection point above a heat sink.
2. We now use a different heat paste, which has a different consistency as well as much higher adhesive strength, resulting in a more even spreading of the paste between PCB and heatsink when the fixture is screwed together.  
The amount of reduction of both elastic and thermal properties of the new paste is not yet known.

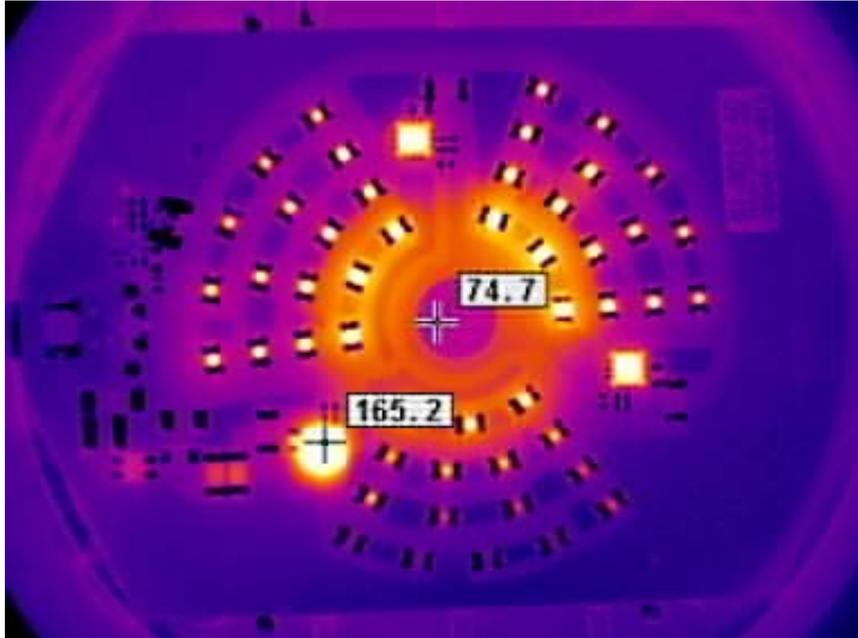
In below picture you can see that at this point, the temperature has already risen to 165.2 ° C (measured with a Ta of 45°C). This also explains the image, which almost always shows only 1/3 of the LED's as flashing.

Moreover, an even higher ambient temperature in the summer may cause temperature to reach the critical threshold in the ICU. Aside from the fact that the IC will not function properly with too high a temperature, this is a negative influence on the lifespan and light colour of LEDs themselves.

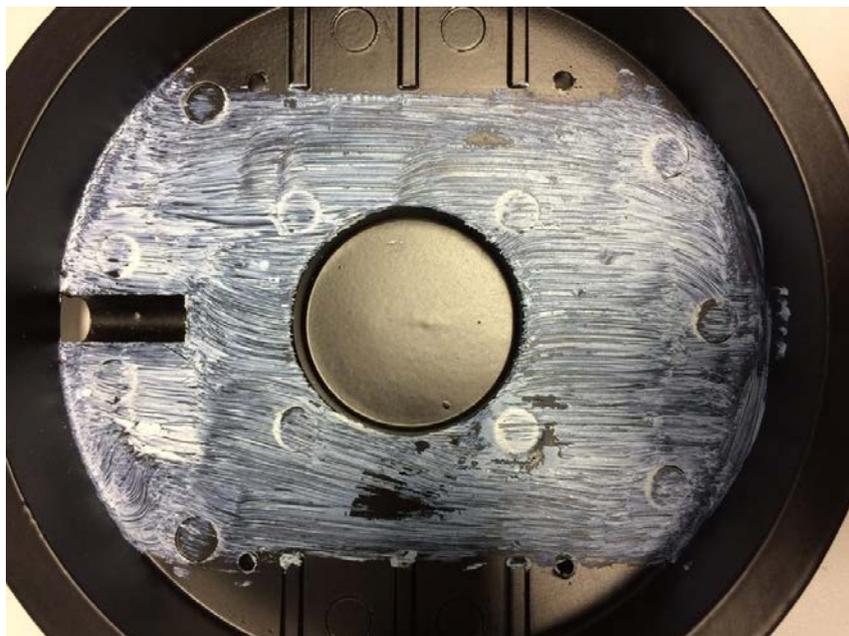
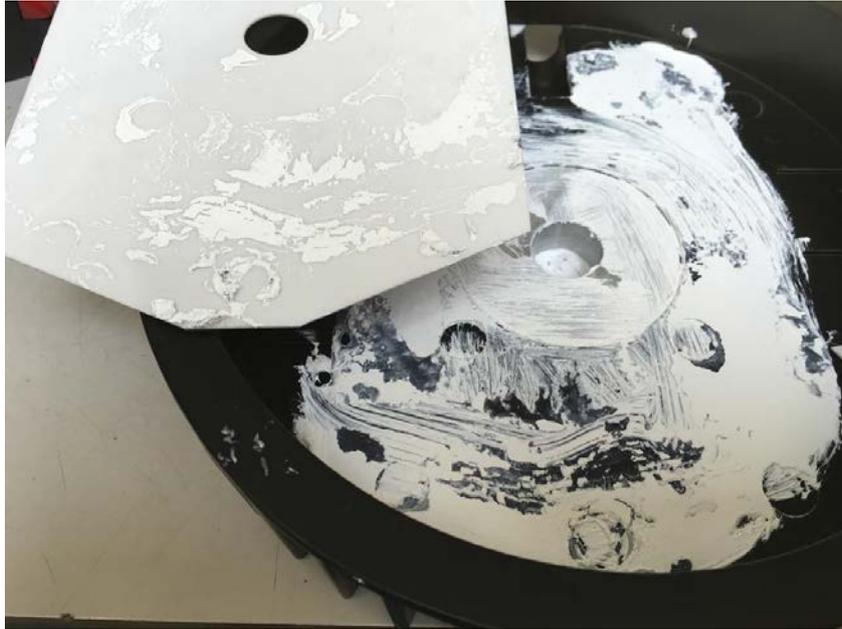
5. Heat Paste has not consistently been used properly, in terms of location as well as in quantity.

A dosing apparatus would be the ultimate solution, so that paste is always applied in the same amount and with optimal distribution resulting in superior consistency.
