Effect of salty air to Illuxtron luminaires.

Installation June 2014 : 44x Fluxe 75
Investigation July 2016

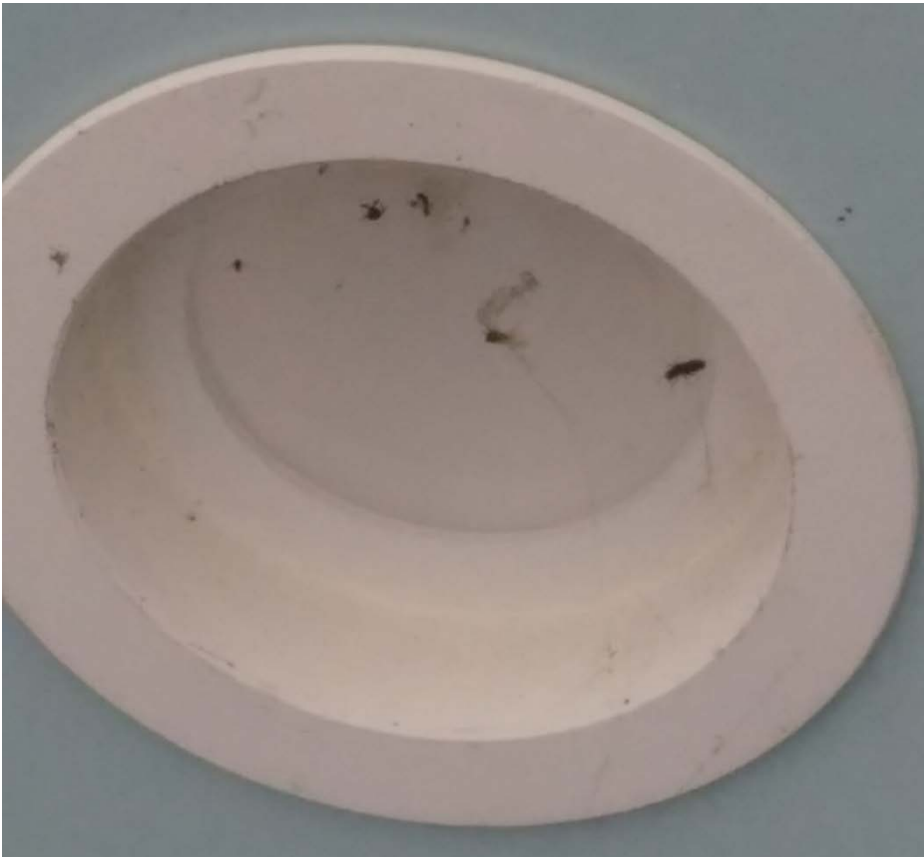
42 spots are just dirty and can be cleaned.
Epoxy powder coating is still intact.

Fluxe 75 is coloured by an original Dupont Epoxy powder, the best resistant to severe situations.

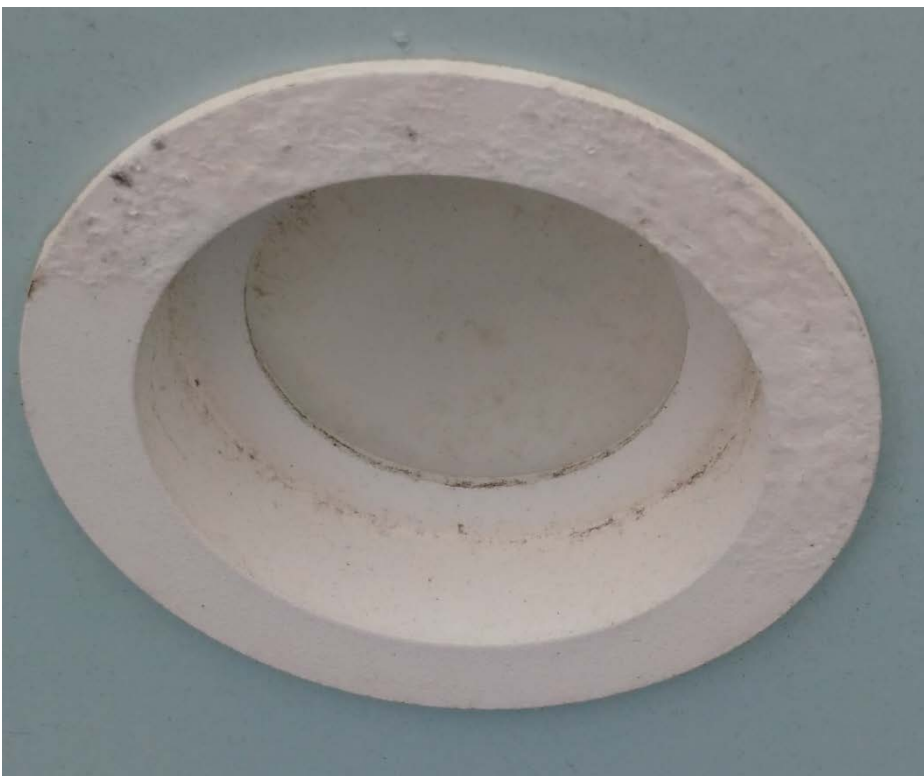
The epoxy powder coating showed bubbles on the surface by 2 of the 44 spots.

These spots were the closest to the seaside at a distance of 50-100mtr.

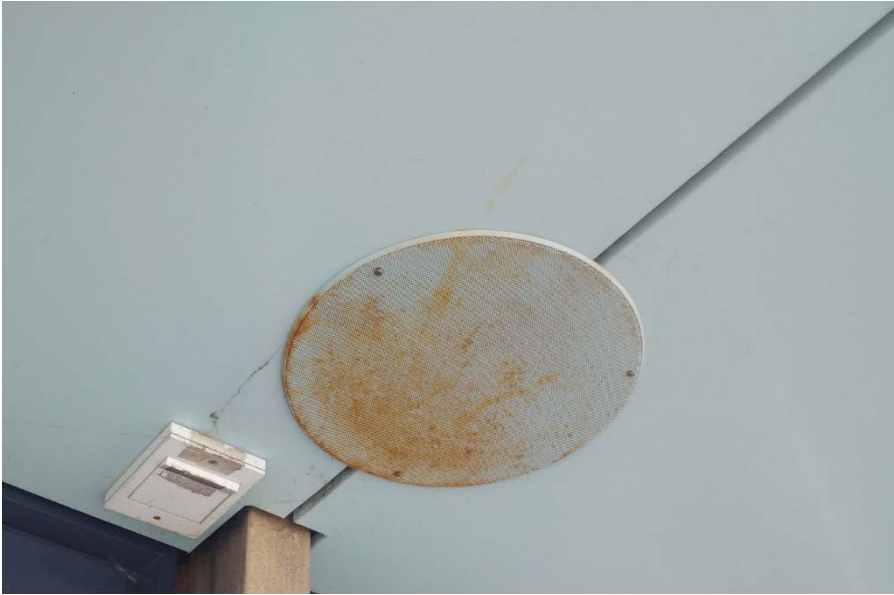
This steel part had corrosion and was already 3 times repainted by the owner. It shows that most products rust way faster than Illuxtron products.

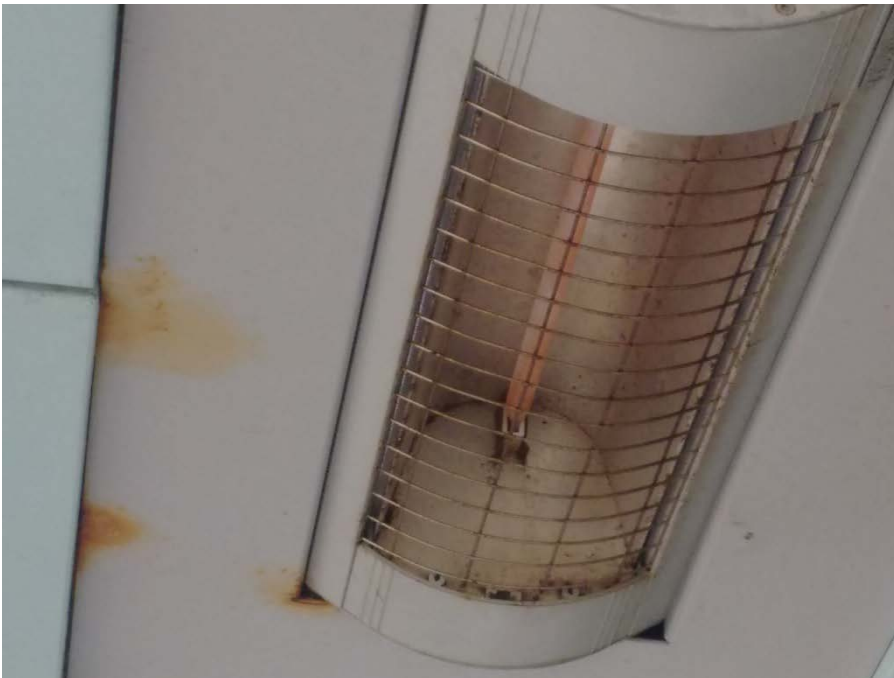
Also this heater was very rusty and is going to be replaced by the owner.

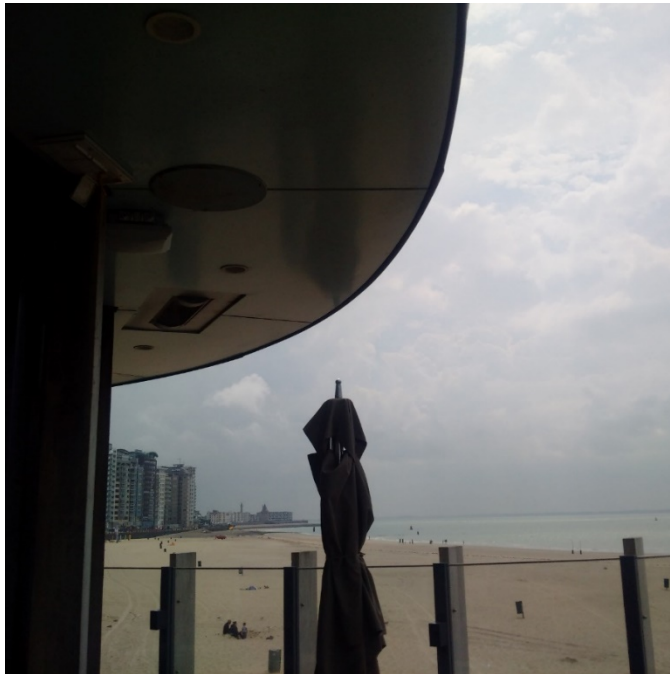
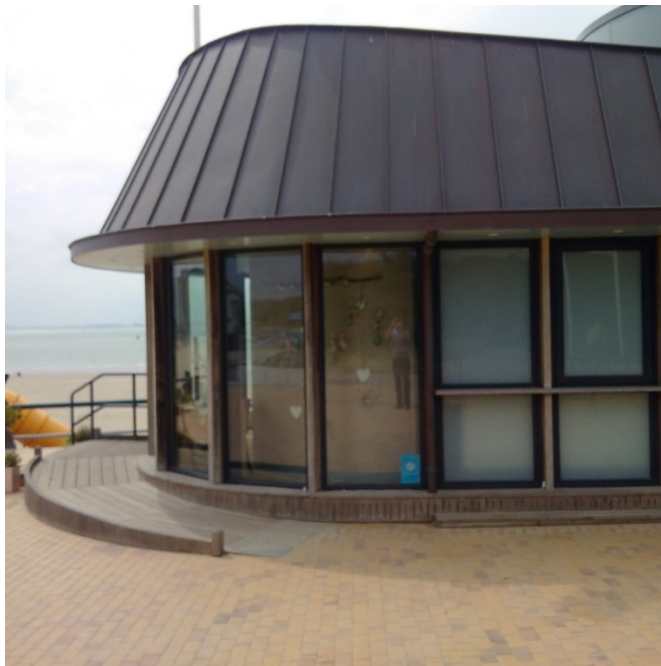
Several investigations show that there are different climates in the Netherlands. Most severe conditions are within 10km from the coastline. Extreme conditions can be found within 500mtr from the seaside (like in this project).

Our Fluxe 75 can be used outside in cove lighting but we cannot guarantee that our luminaires will stay undamaged for a long period.
