# Flickering issue with 185 HV

Investigation Report  
R&D Illuxtron International  
August 2016

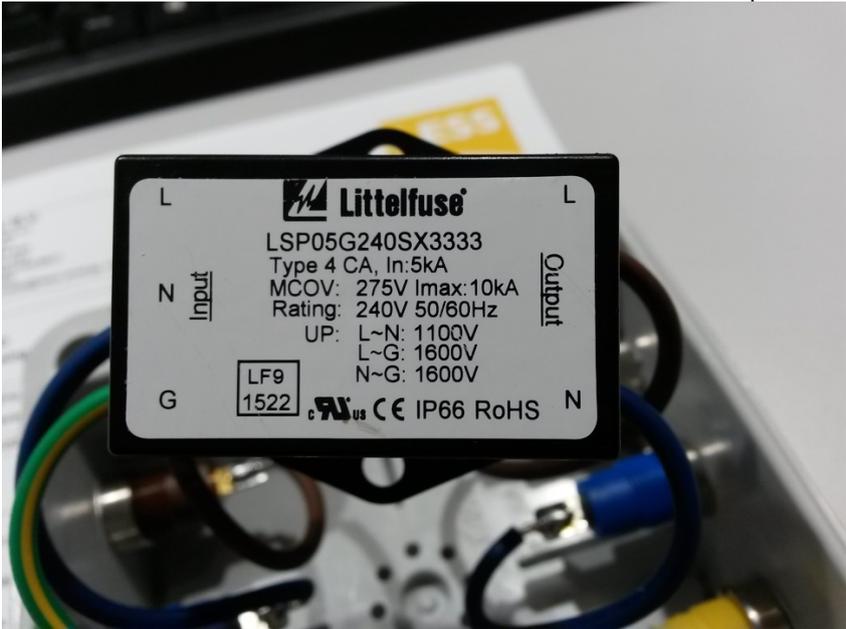
8. In addition to the AC-DC cable we also offer the Littelfuse surge filter. This product has been tested and will filter out surges between 1100 and 6000V. It is intended for projects where large surges in the power supply may be present coming from other equipment. In projects where these have been installed, no more incidents of defects have reported.
